Manhole Inspection Summary

Manhole # S47K2_012MH

Location Address: **1651 Ceddox St.** Cross Street: **Pennington Ave.**

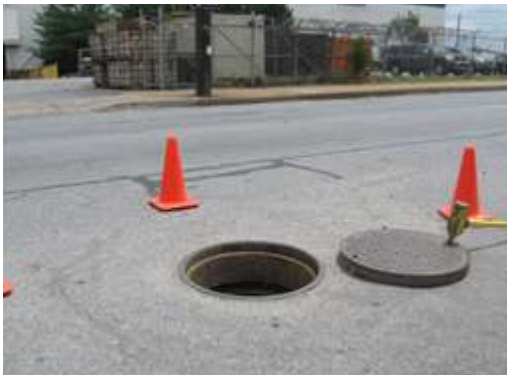
Location View

1651 Ceddox St.

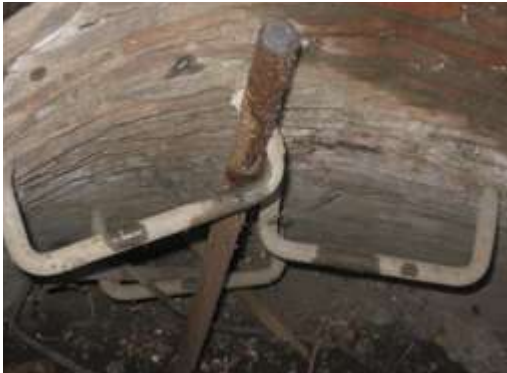
Steps Count: **3** Missing: **0** ☒ **Corroded**

steps

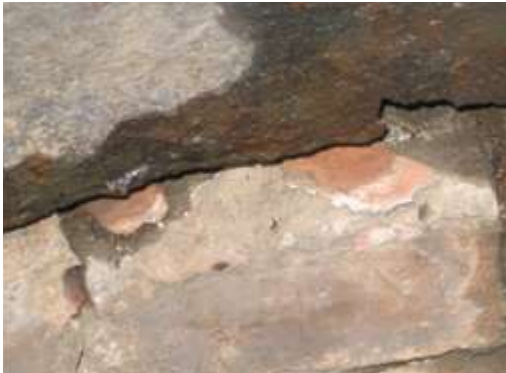
Defect 1

Chimney / Frame Adjustment ☒ Exists Material: **Brick** ☐ Parged Height: **14** (in.)
Condition: ☐ Sound ☐ Cracked ☐ Root Intrusion ☒ **Loose Brick** ☐ Deteriorated
Infiltration: ☒ None ☐ Joint ☐ Cracks ☐ Mortar ☐ Roots ☐ Wall

loose bricks under frame

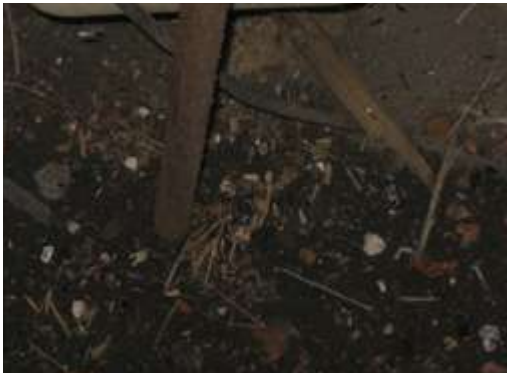
Defect 2

Channel Material: **Brick** ☐ Parged
Channel Exposure: **Fully Open** Junc Dist: **0** nearest .5 ft. Azimuth:
Condition: ☐ Sound ☐ Cracked ☐ Root Intrusion ☐ Deteriorated ☐ Leaks ☒ **Debris**

debris
